ALKALI METAL RESISTANT ELECTRICAL DEVICES

W. H. Snavely
R. E. Stapleton
A. J. Krause
Westinghouse Electric Corporation

TECHNICAL REPORT AFAPL-TR-68-61

June 1968

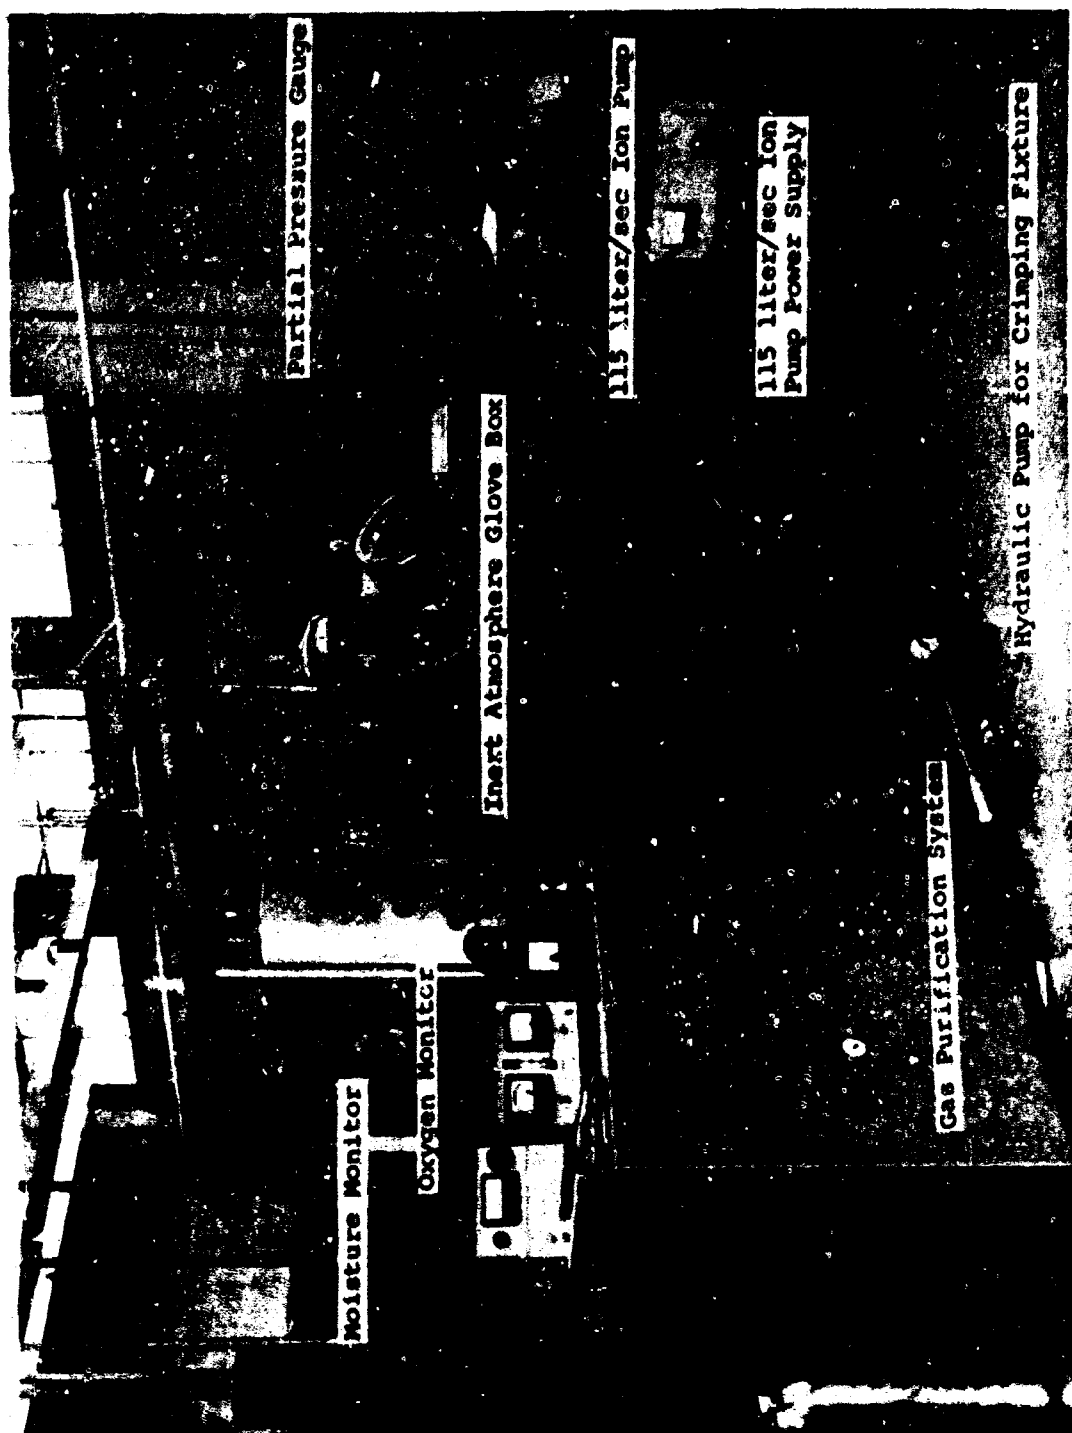
Figure 1. Inert Atmosphere Glove Box System

An inert atmosphere glove box system was used extensively throughout this program. Its main function was to provide a moisture and oxygen-free argon atmosphere for the operations of potassium handling and tungsten-inert-gas (TIG) welding. Figure 1 shows the inert atmosphere glove box system.

The glove box was equipped with an antechamber (shown in figure 1 on the right end of the box) and an evacuation subsystem located under the box. This evacuation subsystem consisted of a mechanical roughing pump, an oil diffusion pump, and a liquid nitrogen baffle. Glove box atmosphere was maintained as high purity argon by circulating the gas through a purification subsystem. This subsystem was a modified Vac Atmosphere "DriTrain". Atmosphere purity was verified by monitoring gas from the glove box for moisture with a CEC Moisture Monitor and for free oxygen with a Westinghouse Oxygen Gage. These instruments are shown in figure 1. Most glove box operations were performed with the combined moisture and oxygen contents less than 5 ppm.

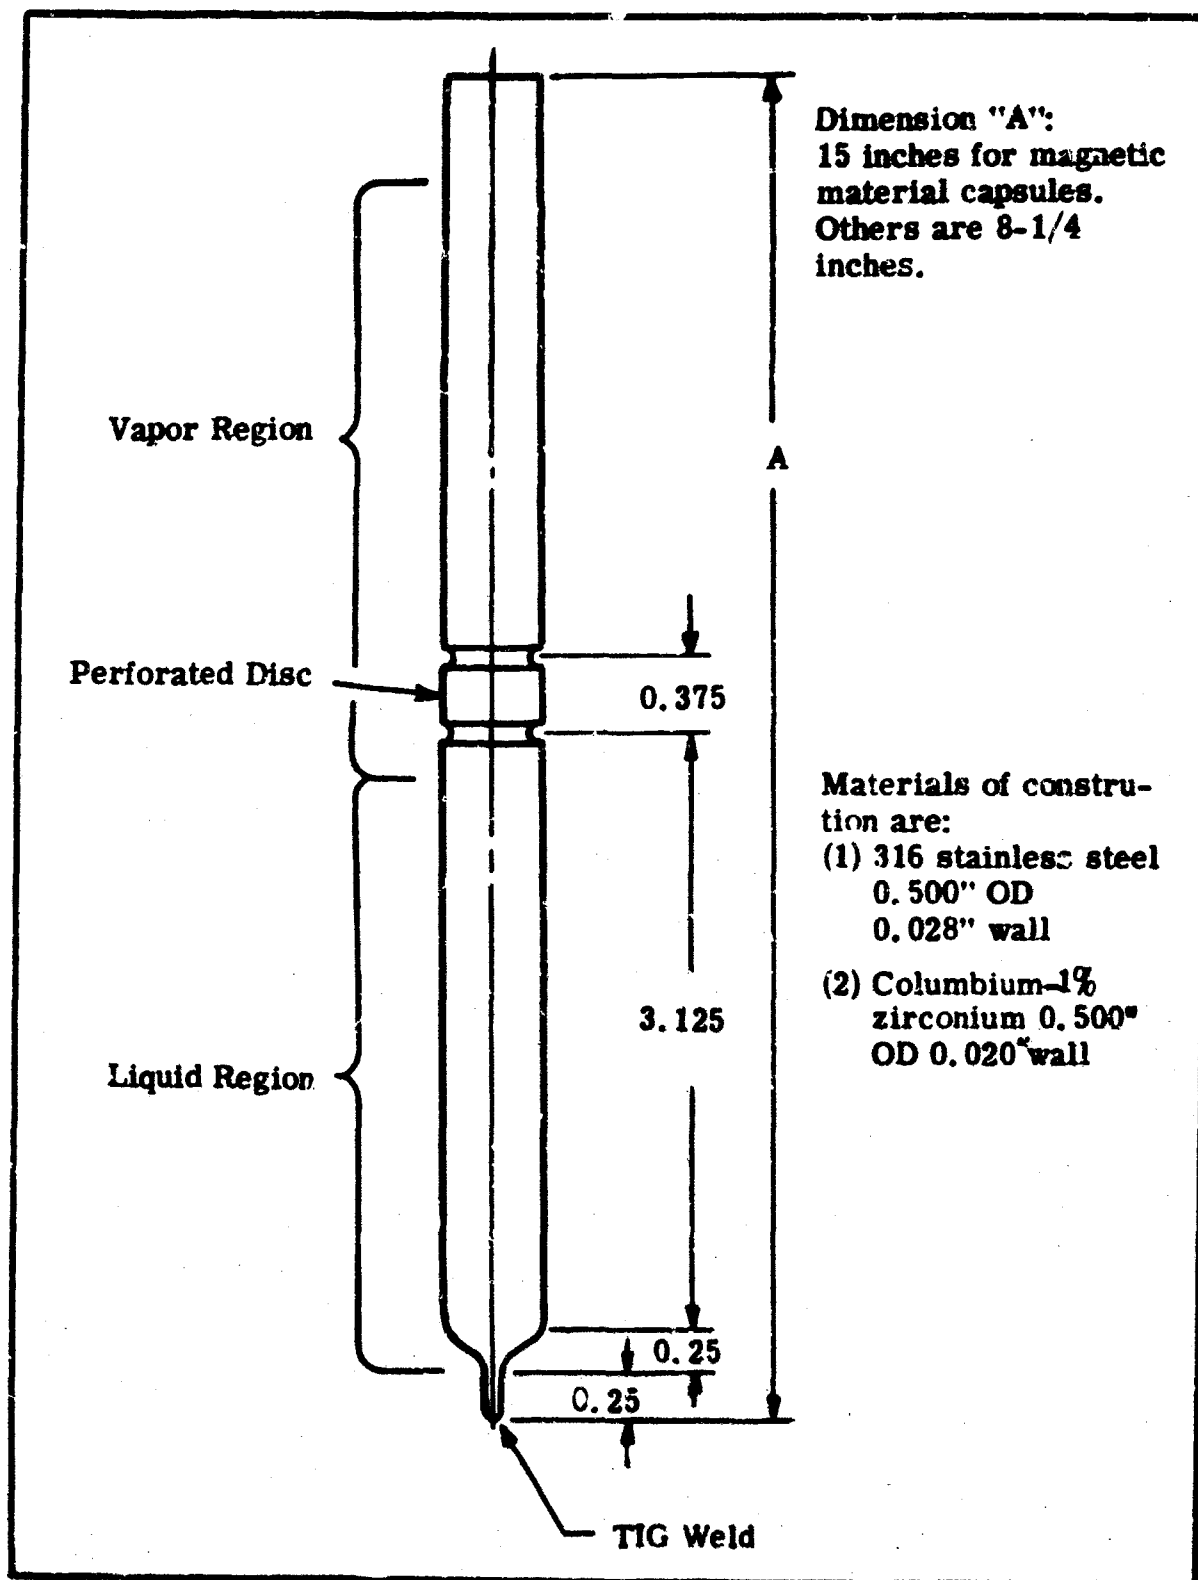
Figure 2. Exposure Capsule for Potassium Vapor Exposure Tests

Exposure capsule designs are shown in figure 2. Capsules were made of 347 stainless steel (used for long term tests of ceramic materials), or columbium-1% zirconium

(used for long term exposures of metallic materials). These materials have demonstrated potassium resistance^{1*}. Table II gives the chemical analysis of the stainless steel tube material. Table III gives chemical analysis of columbium-1% zirconium materials at various stages of forming. The oxygen content of the drawn 0.500-inch outside diameter columbium-1% zirconium tube was less than the specified maximum of 250 ppm.

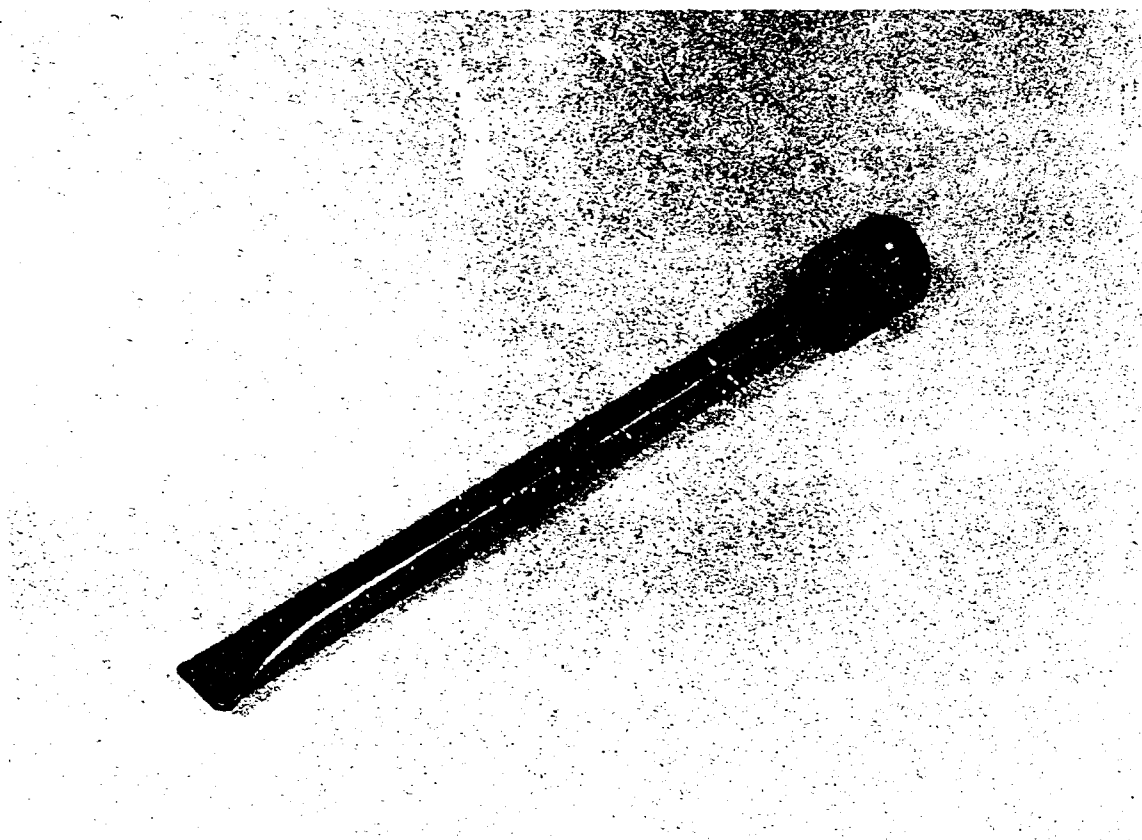
Figure 3. Stainless Steel Exposure Capsule Prior to Potassium Loading

Subsequent to pre-cleaning, the ends of the tubes were crimped and closed by TIG welding. Each weld was then tested for leaks, using a helium leak detector and all were found to be leak tight.

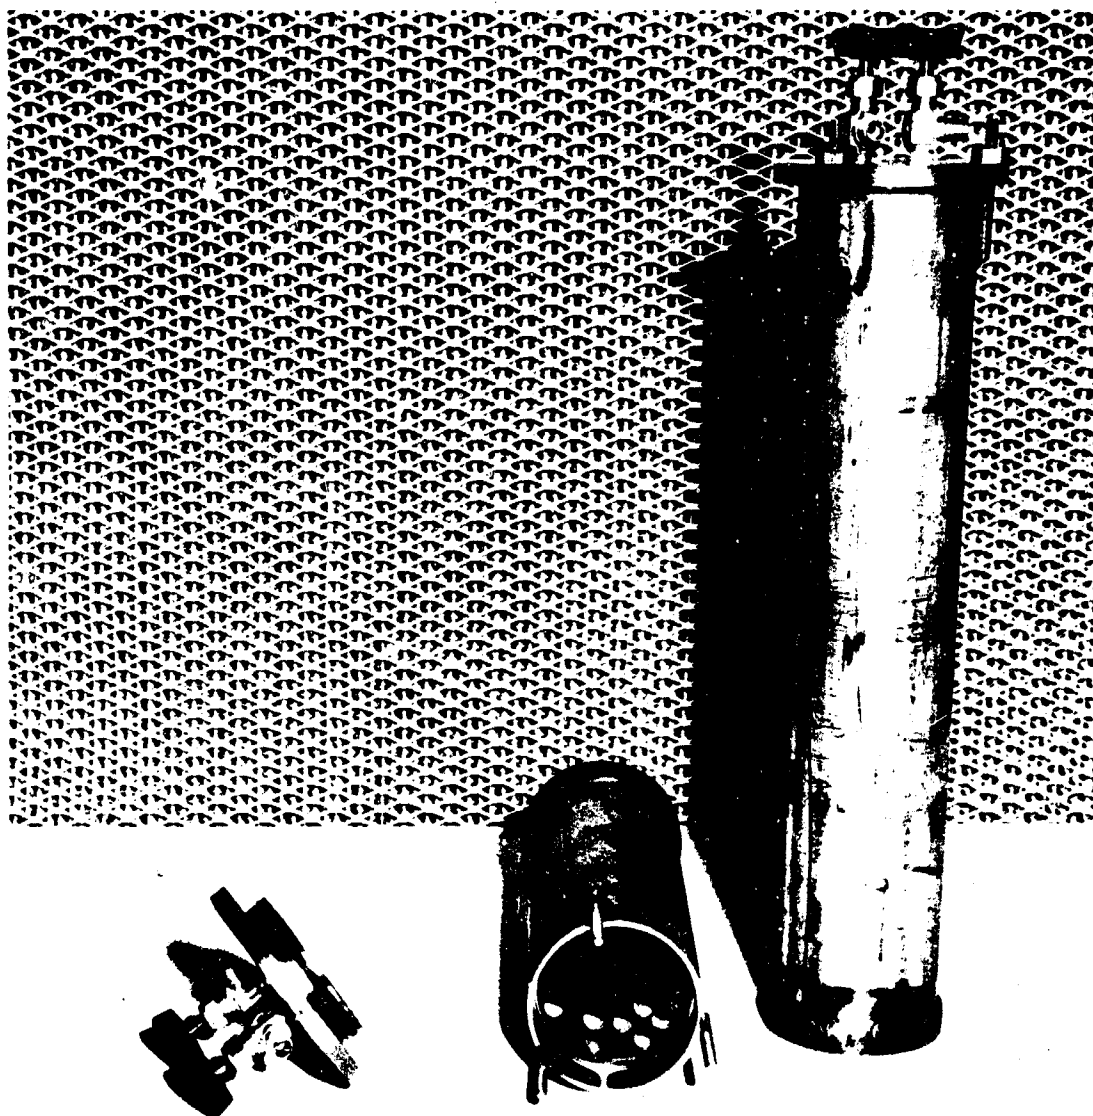
Figure 4. Assembled and Disassembled Transport Containers

Cleaned and sealed capsules were shipped to the potassium supplier (MSA) in transport containers pressurized with high purity argon. Containers were made of three inch schedule 40 type 316 stainless steel pipe with a 0.375-inch plate of the same material welded to form a bottom. The top was of type 316 stainless steel with an O-ring

tops were put on, the valves closed, and they were removed from the glove box. Once outside the glove box, the transport containers were pressurized to 40 psig with high purity argon and checked for leaks. They were then transported and received for specimen loading and final sealing.

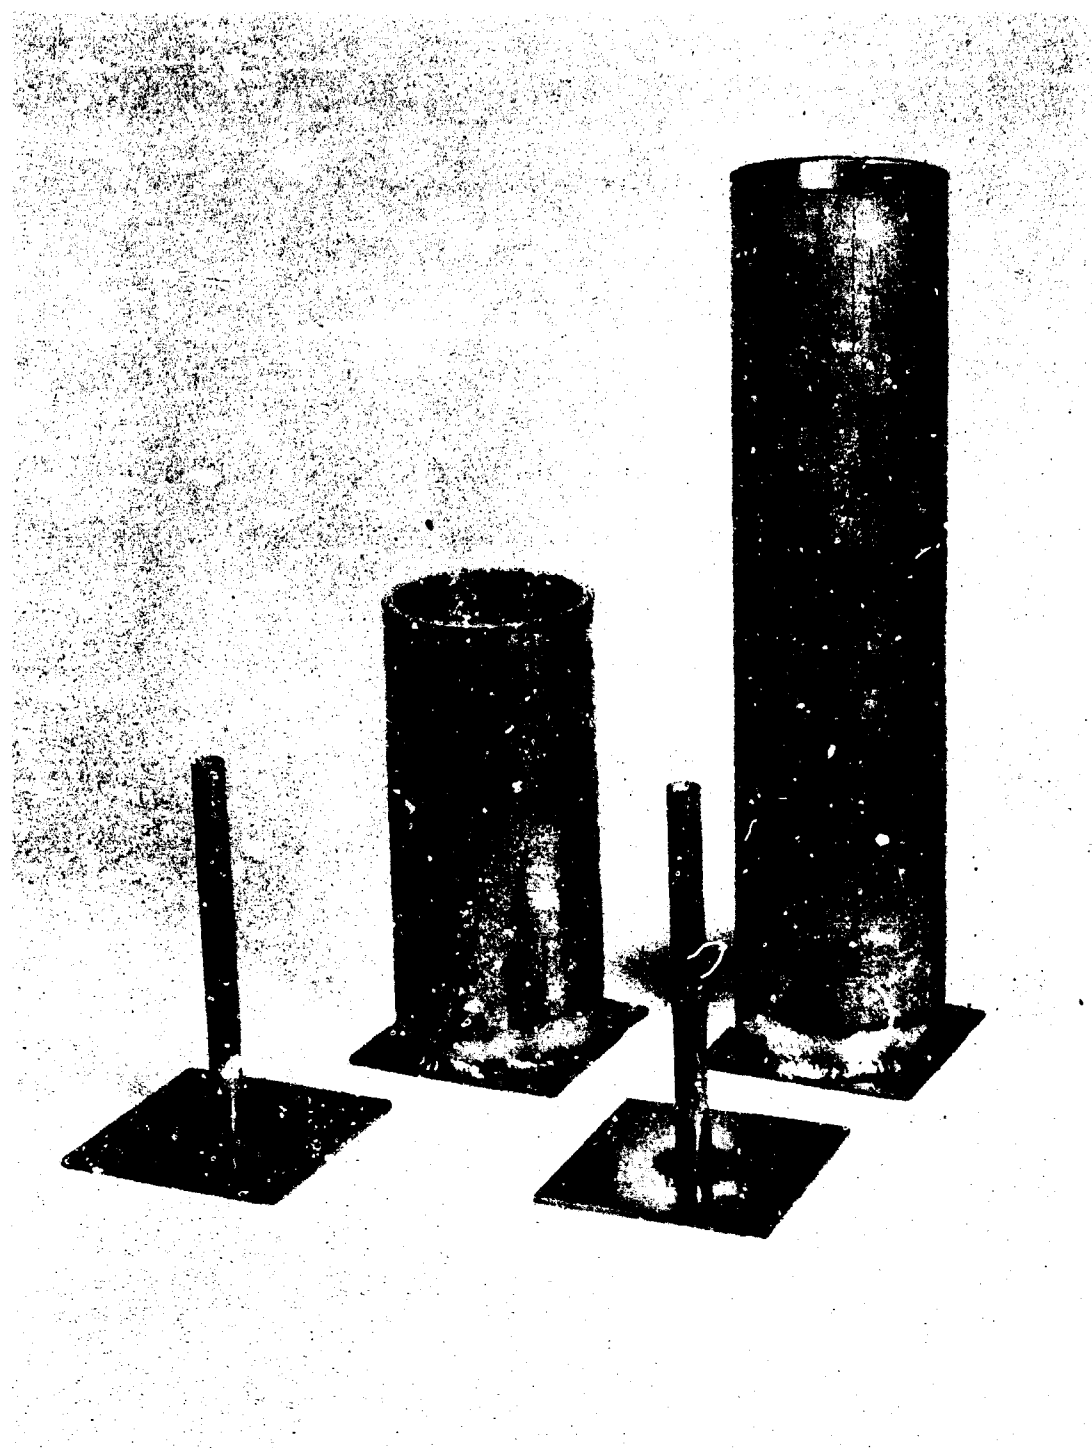
Figure 6. Stainless Steel Containers for Potassium Vapor Exposure Capsules

Capsules to be exposed for a given time duration were placed together in cleaned containers. Titanium sponge was added to act as a getter for surface oxygen from the container. Container tops were then welded in place and the weld was checked for leaks. Loaded containers were evacuated, crimped, and sealed by TIG welding as were the capsules. Sealed containers were placed in air furnaces for either 600° or 850°C exposure. Typical capsule containers are shown in figure 6.

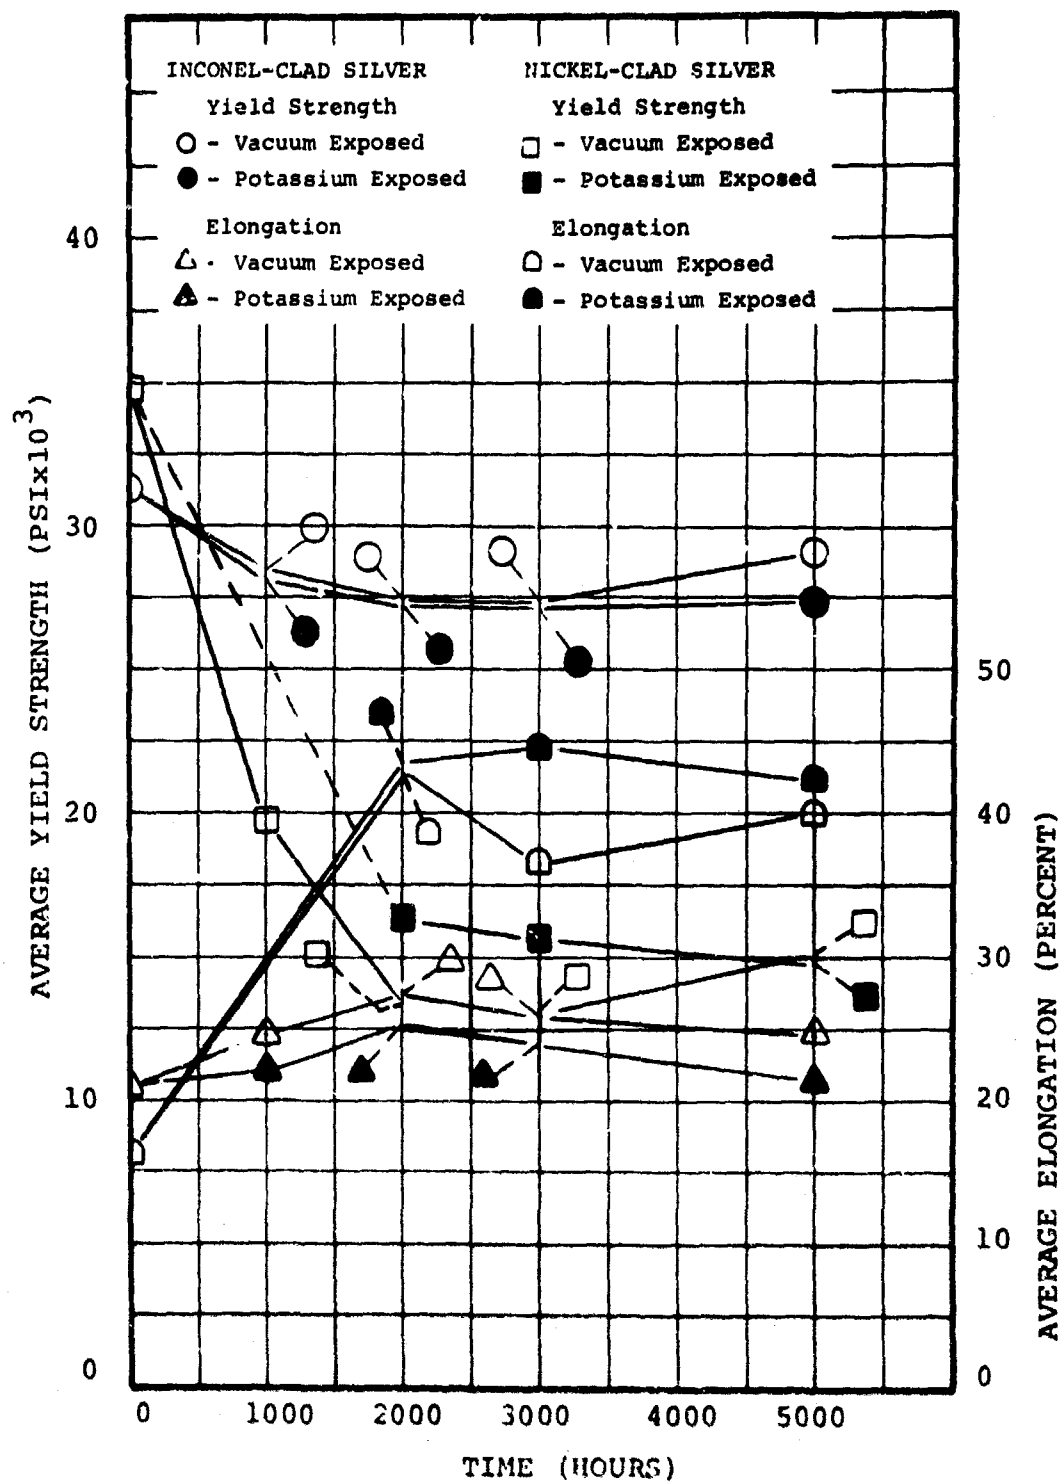
Figure 11. Average Mechanical Properties of Inconel and Nickel Clad Silver Conductors

Mechanical tests were performed on conductor materials. These tests gave values for actual yield point or yield strength determined at 0.2% offset and percent elongation in two inches for both thermal-vacuum and thermal-potassium exposed specimens. These values were calculated from measured parameters as discussed in Appendix I.

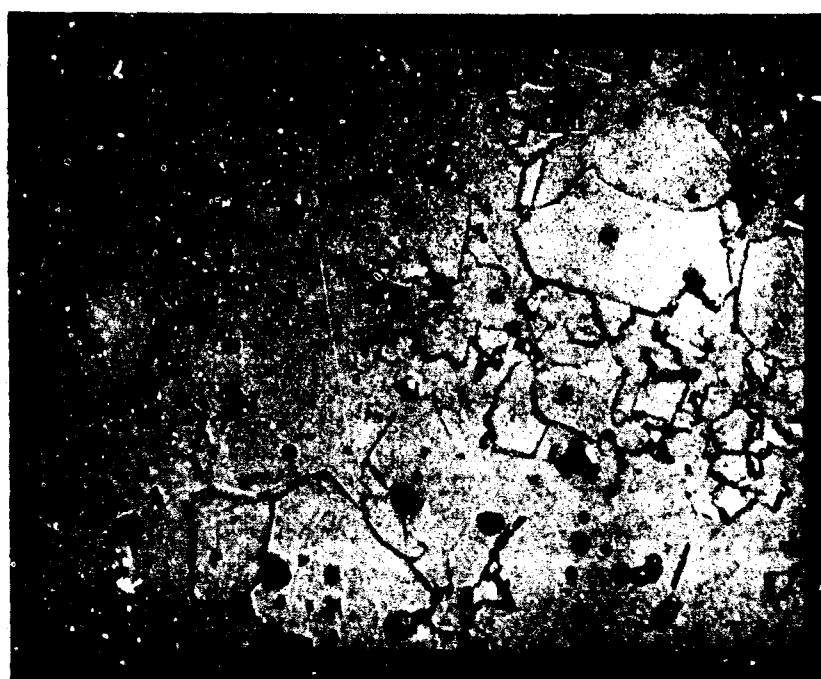
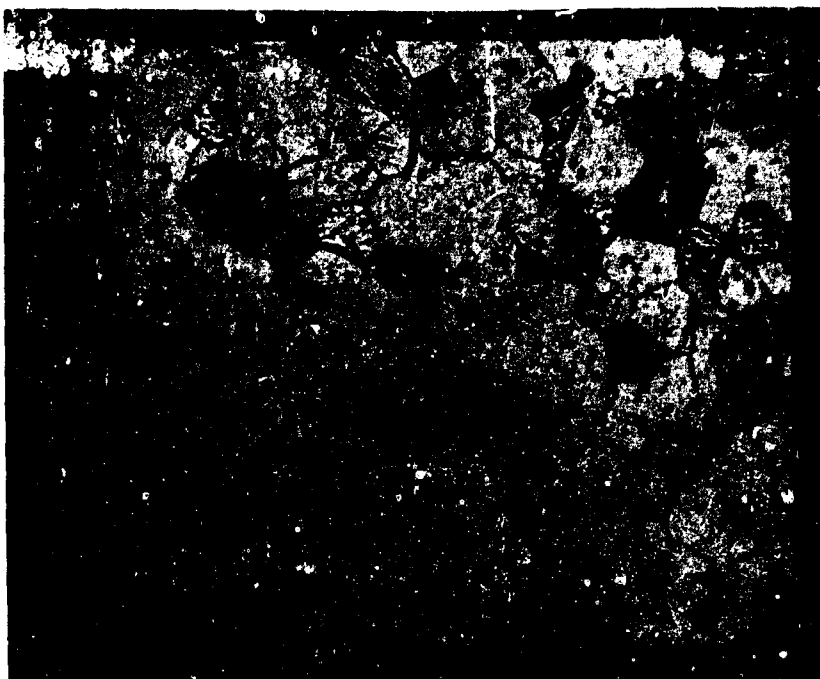
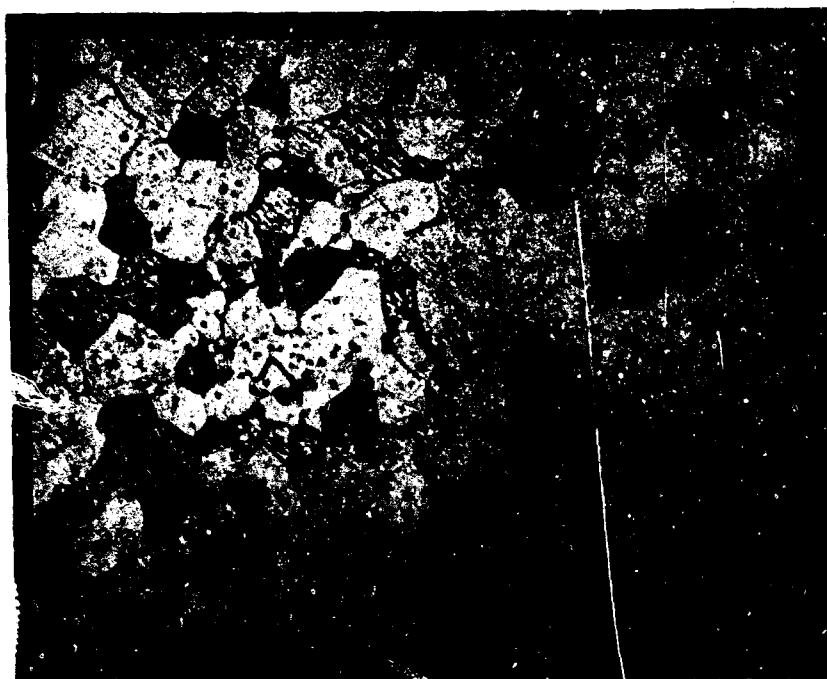
Figure 22. Micrographs of Beryllia Before and After 600°C Potassium Vapor Exposure

Alite 612
(before exposure)
(625X)

Alite 610
(before exposure)
(625X)

BeO
(before exposure)
(250X)

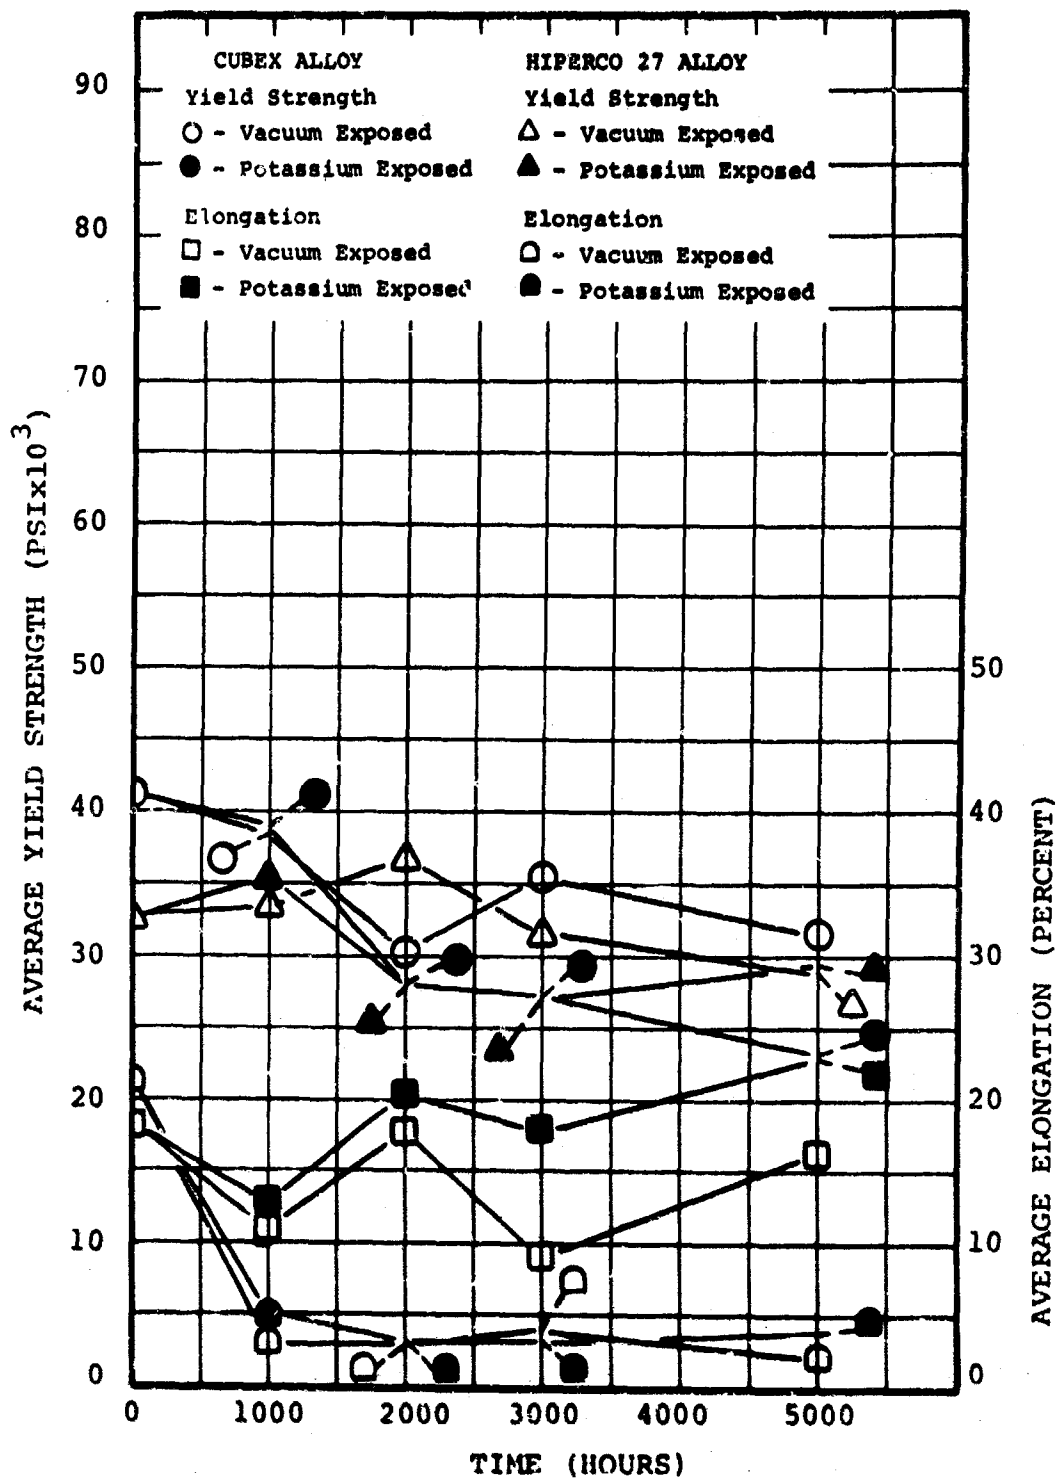
Figure 27. Average Mechanical Test Data for Magnetic Materials

Mechanical tests were performed on magnetic materials. Data from these tests were used to calculate 0.2% offset yield strength and elongation values. Individual values were compared with average values and a calculated standard deviation (see Appendix II). A revised set of values was calculated when a value was outside the standard deviation. Mechanical property values, their averages and the coefficients of variation are given in table XV. Average data from this table are plotted in figure 27. Potassium did not appreciably affect either material.

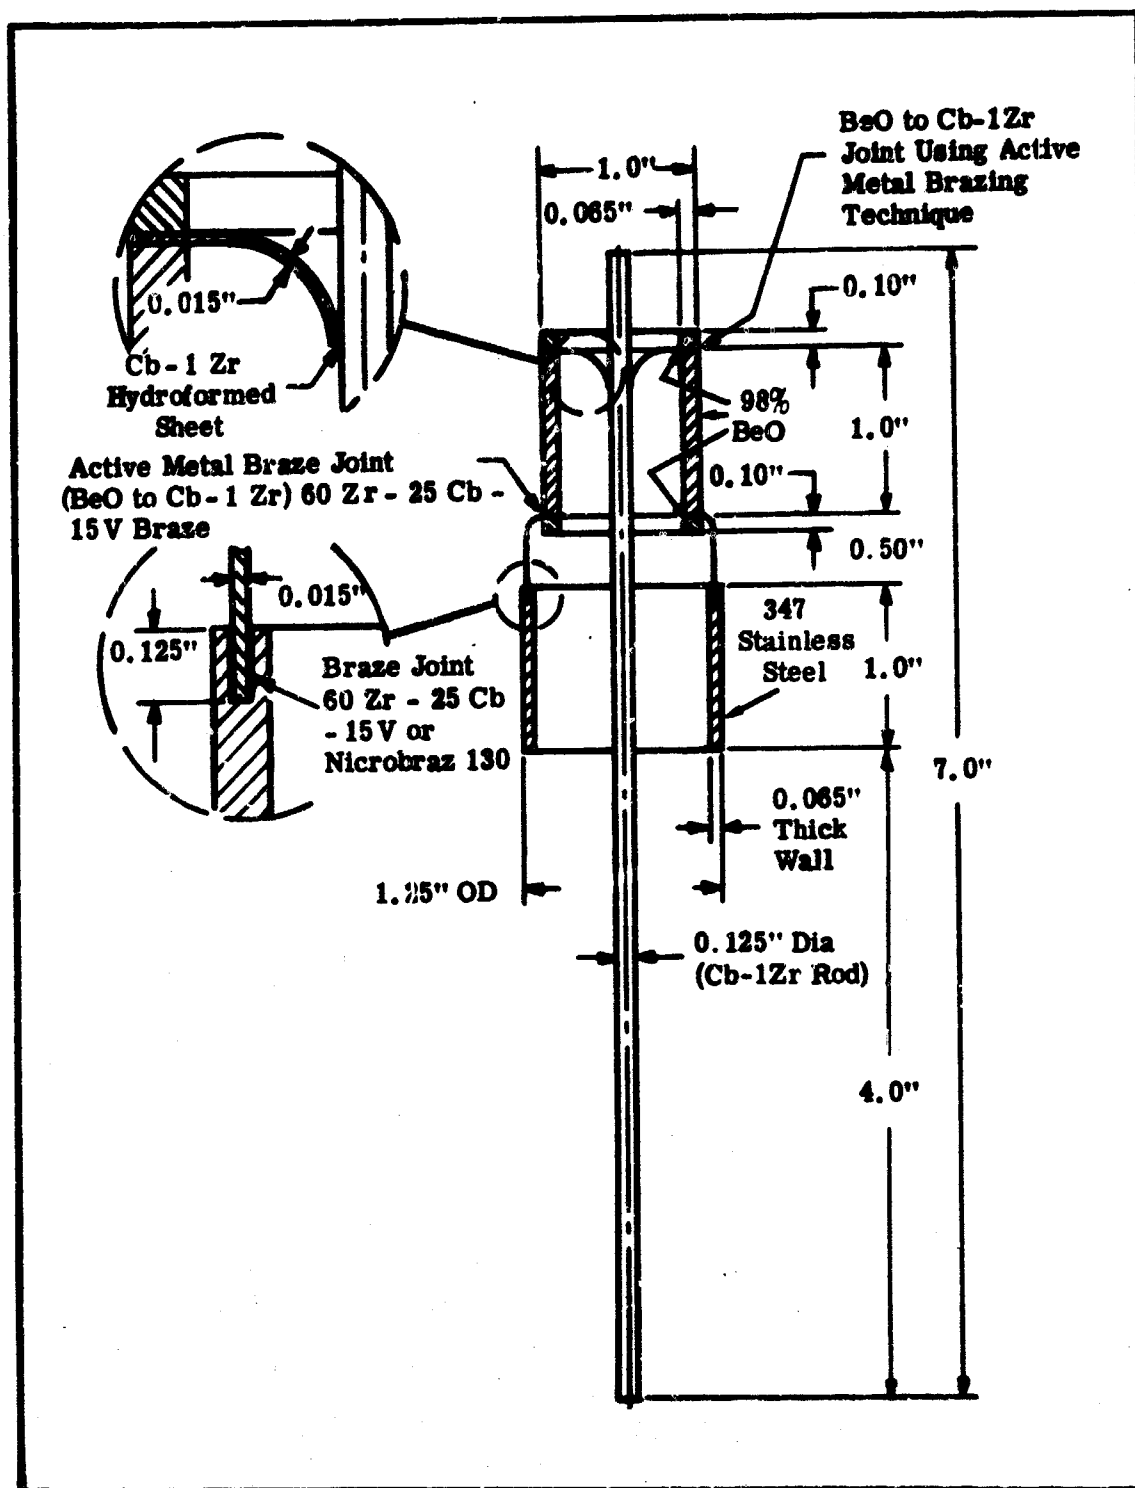
Figure 21. Ceramic-to-Metal Electrical Feedthrough Terminal Seal Configuration

Terminal feedthroughs were tested for leaks with helium before assembly into the top plate.

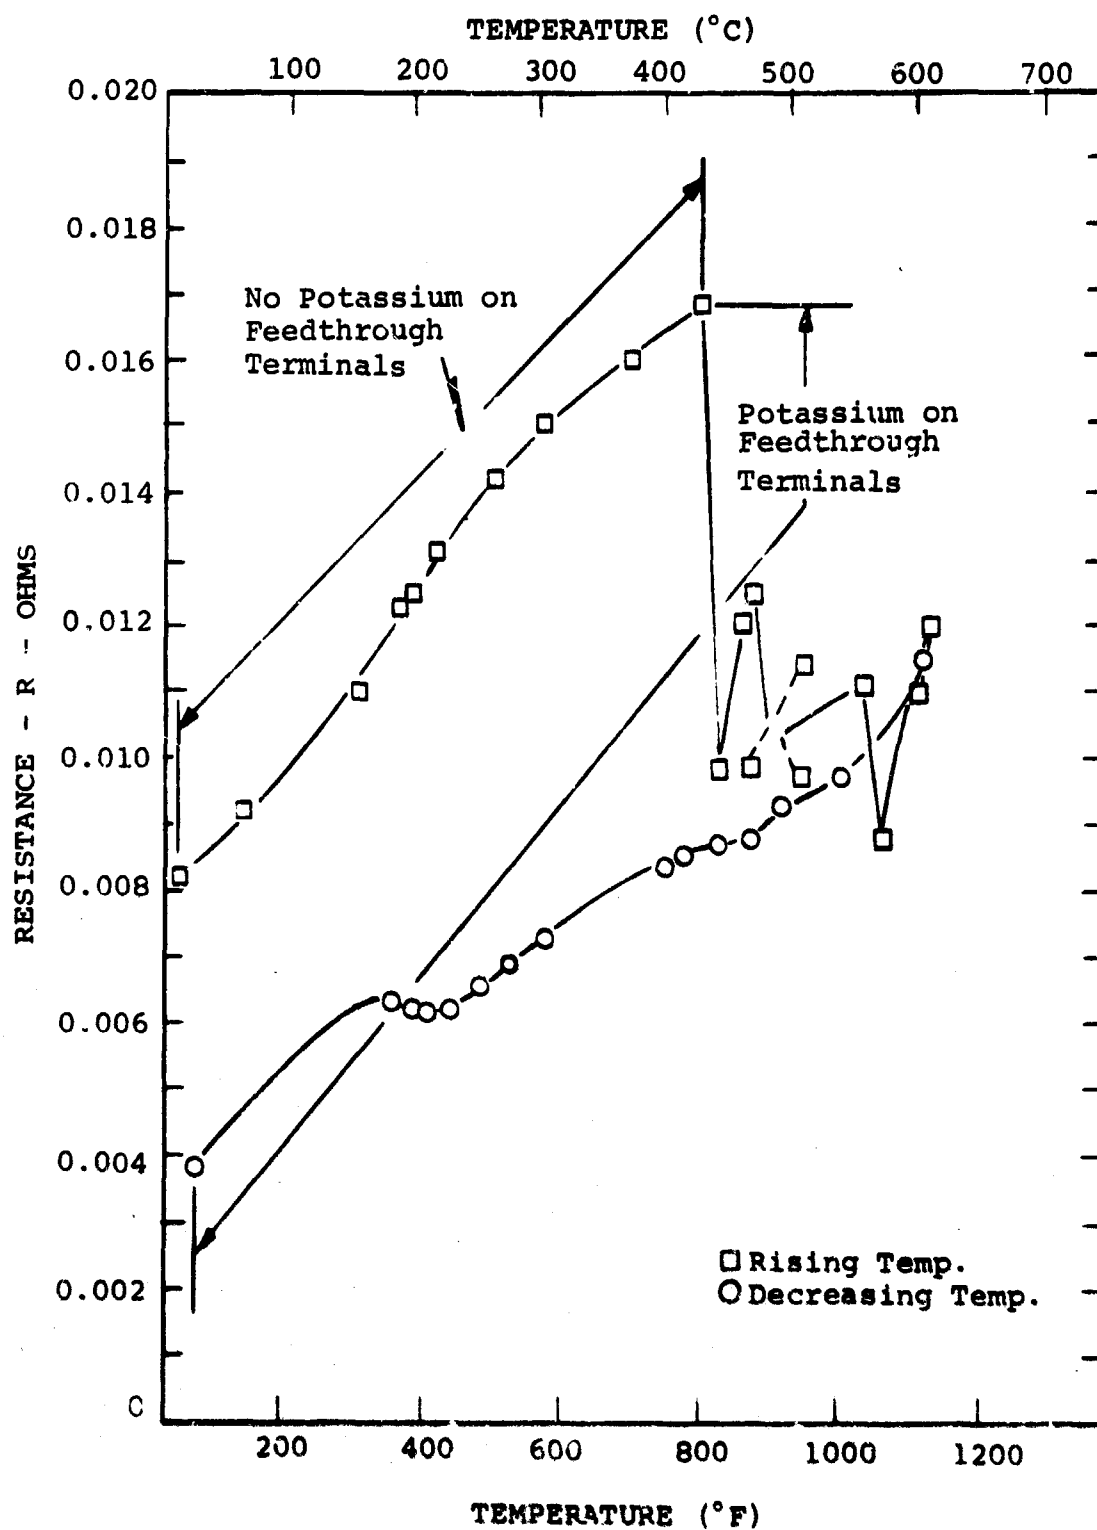
Figure 34. Electrical Resistance-Temperature Relationship, Two-Terminal Test Container With Potassium

An attempt was made to eliminate the electrical short circuit (0.3 ohm), by energizing the conductor with a high current from a low voltage source. The two-terminal container was not raised to 600°C with an external source of heat; instead, the temperature was allowed to rise as a result of the electrical input as shown in table XIX. After the 164 minute interval, the test container was allowed to return to room temperature (~25°C). An electrical resistance measurement taken from the terminal seal to the stainless steel container indicated the resistance had increased to 300 ohms. This effect is explained by a partial elimination of the potassium film causing the 0.3 ohm electrical short circuit. The potassium vapor could have boiled off the surface of the Lucalox ceramic portion of the electrical terminal seal giving, in effect, a conductive path from terminal to container with a reduced cross section.

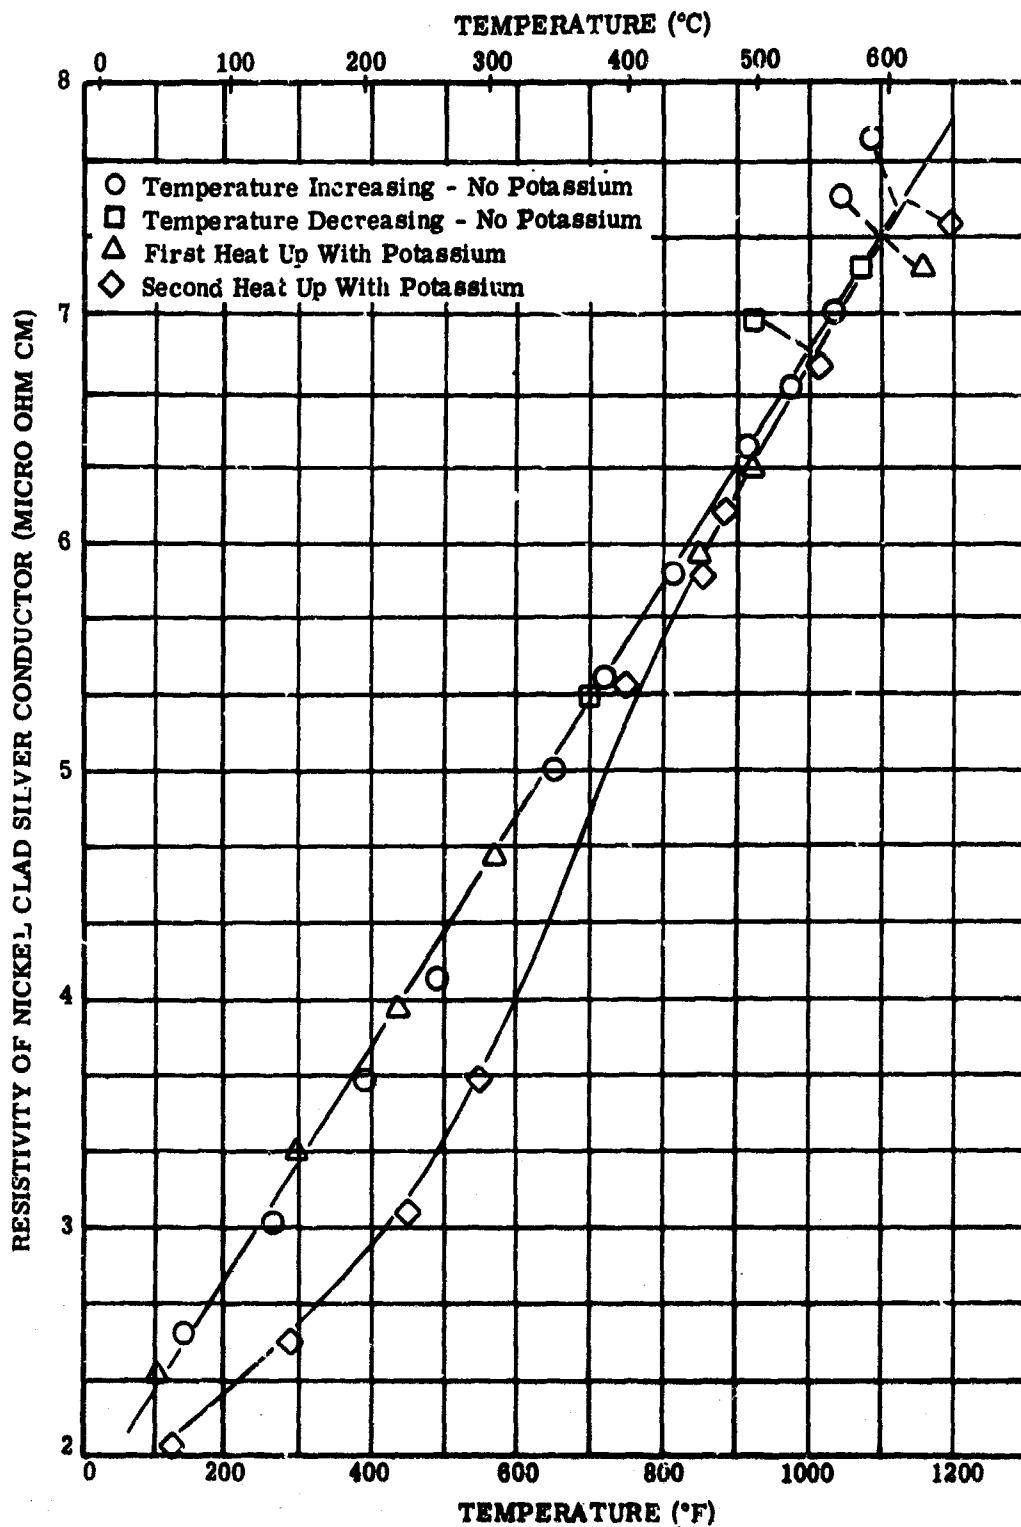
Figure 35. Apparent Resistivity of a Nickel-Clad Silver Conductor as a Function of Temperature with and without Potassium (Four-Terminal Test Container)

In the first potassium heat up, at a temperature of approximately 450°C, the potassium wetted the beryllia insulator portion of the terminal seals (as it had wetted the Lucalox insulator in the terminal seals of the two-terminal seal container) forming a conduction path between seal terminals through the test container. The conduction path at this temperature had a substantially higher resistance than the nickel-clad silver conductor and, therefore, did not appreciably affect the resistance of the test circuit as the temperature was increased to 607°C. After several hours at 607°C, the container was cooled to room temperature, removed from the furnace, and checked for possible potassium leaks. No leaks were found. The resistance from terminals to the test container, measured with a Kelvin bridge, was 0.015 ohm. At this time, feed-through terminal seal heaters and thermocouples were added to the test container.

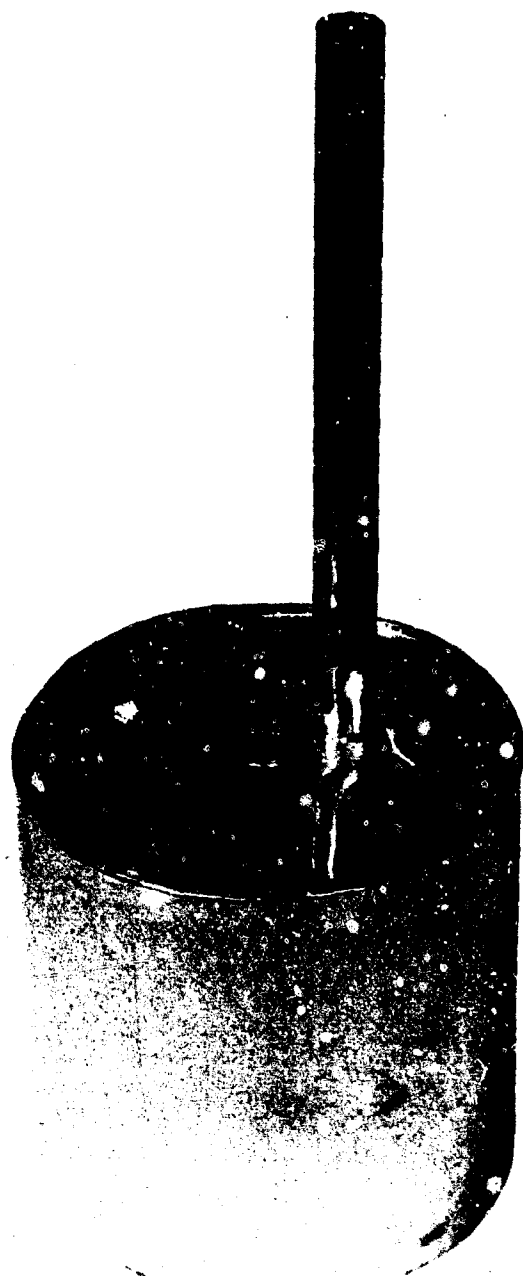
Figure 40. Weldsa Rowland Ring Core Box

No. of Rowland Rings - 110
Inside Diameter - 3.256 inches
Outside Diameter - 3.890 inches
Magnetic Material Theoretical Stack
Height - 0.88 inch

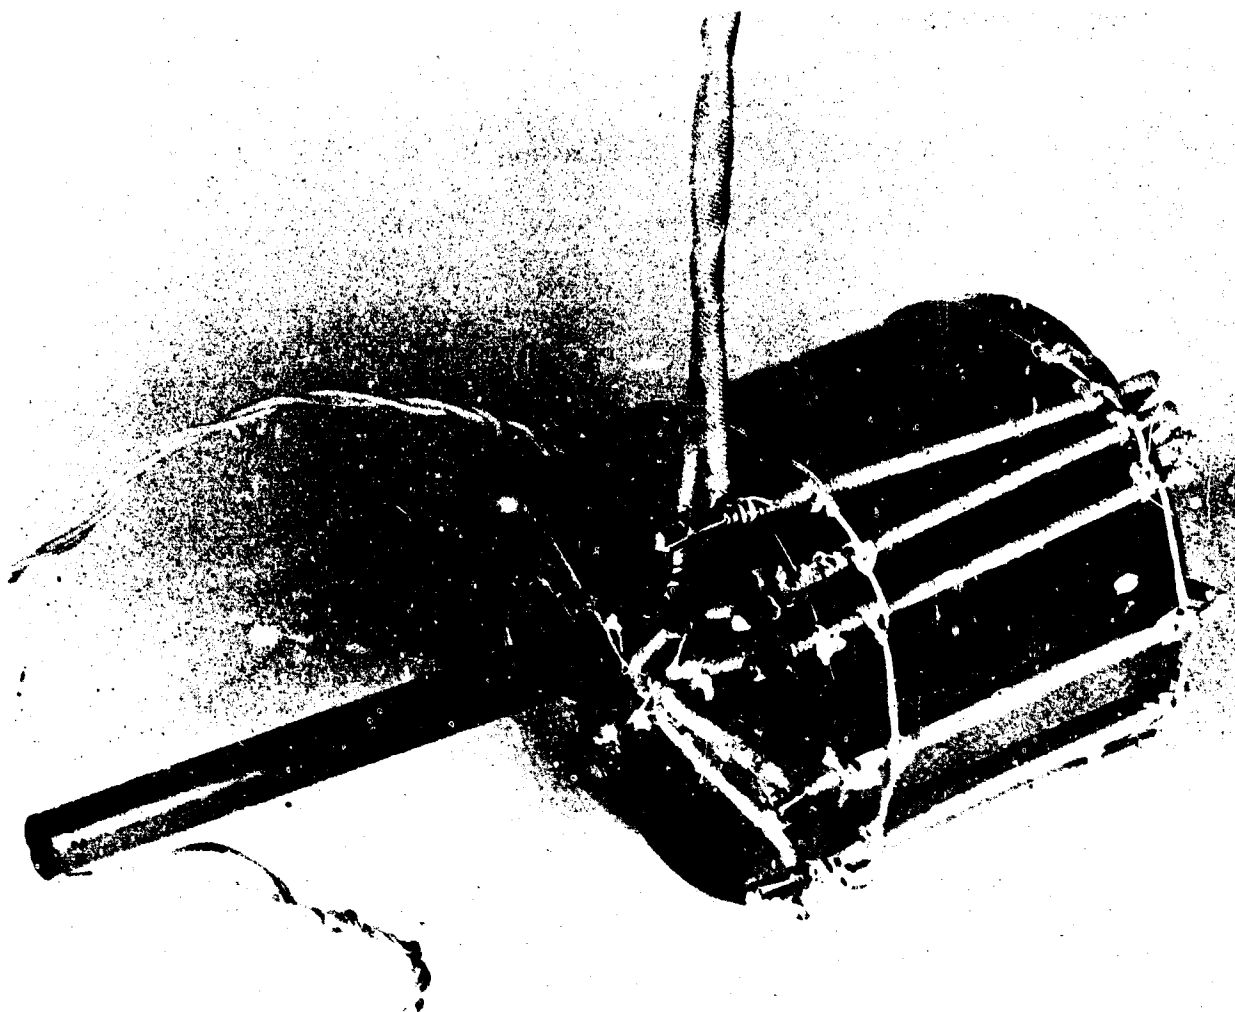
Figure 41. Wound Rowland Ring Core Box

Magnetic tests were run in the hot-wall vacuum furnace at 130° and 600°C. The 130°C tests were at a furnace pressure of approximately 4×10^{-6} torr. A vacuum of approximately 2×10^{-6} torr was used during the 600°C test to maintain oxygen at a level that would not attack the columbium-1% zirconium of the core box. The 130°C test temperature was the equilibrium temperature for the core box heated by electrical losses.

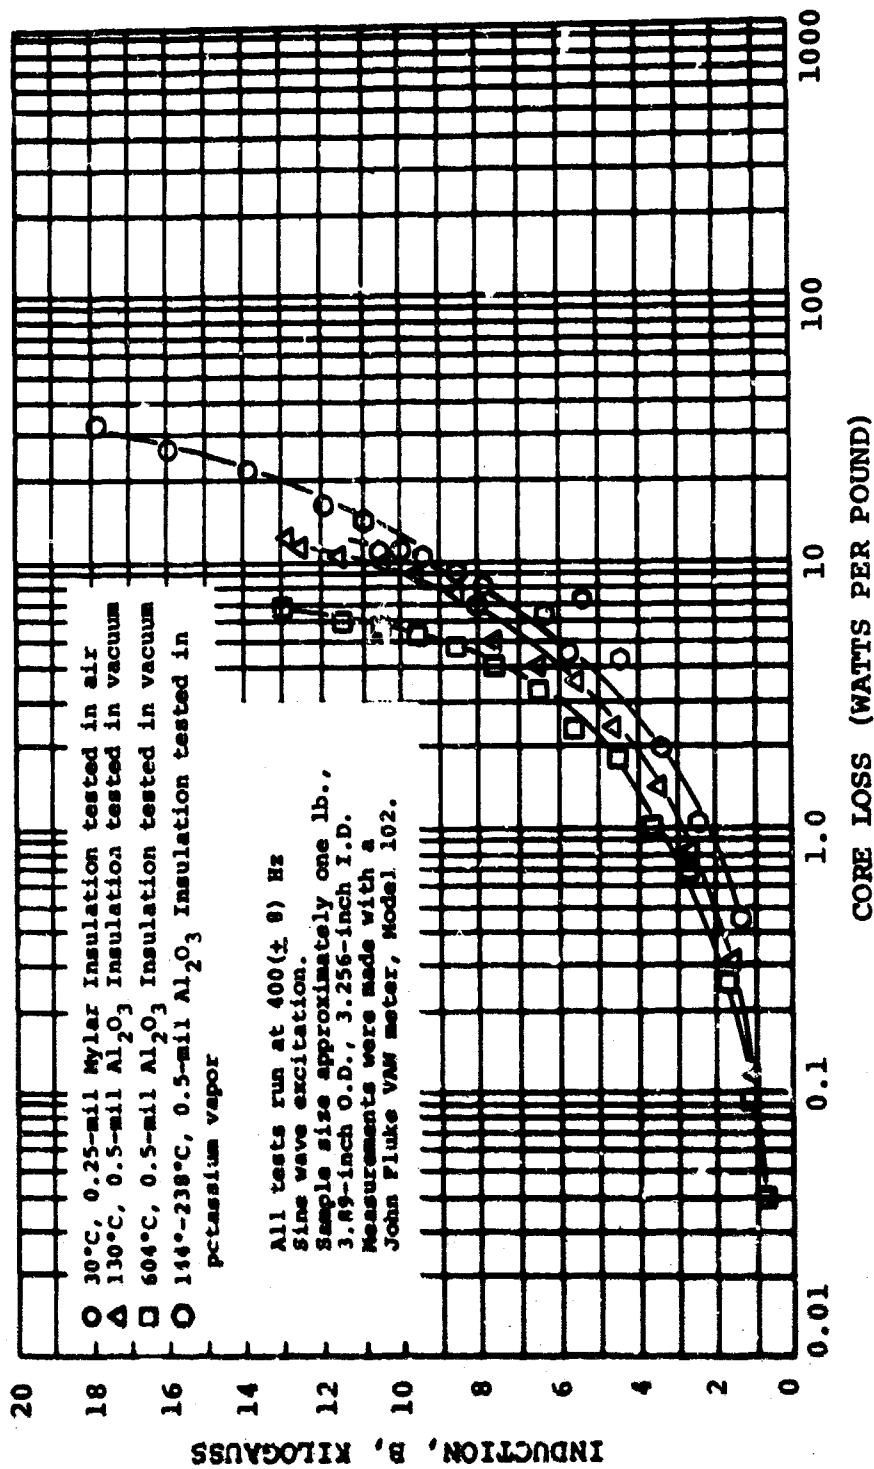
Figure 42. Core Loss, P_c , Annealed 0.008-Inch-Thick Hiperco 27 Alloy Rowland Rings

The eddy currents in the Hiperco 27 alloy are apparently diverted from their normal direction and follow the moving potassium conductor on the
